Stacy L. Balzer  
 Operating Director  
 Service Engineering Operations  
 Ford Customer Service Division

December 14, 2022

**SUBJECT:** **NEW VEHICLE DEMONSTRATION / DELIVERY HOLD**  
**Safety Recall 22S06 - Supplement #2**  
 Certain 2015-2017 Model Year Mustang Vehicles  
 Luggage Compartment Lid Wiring Inspection and Rear View Camera Improper Function

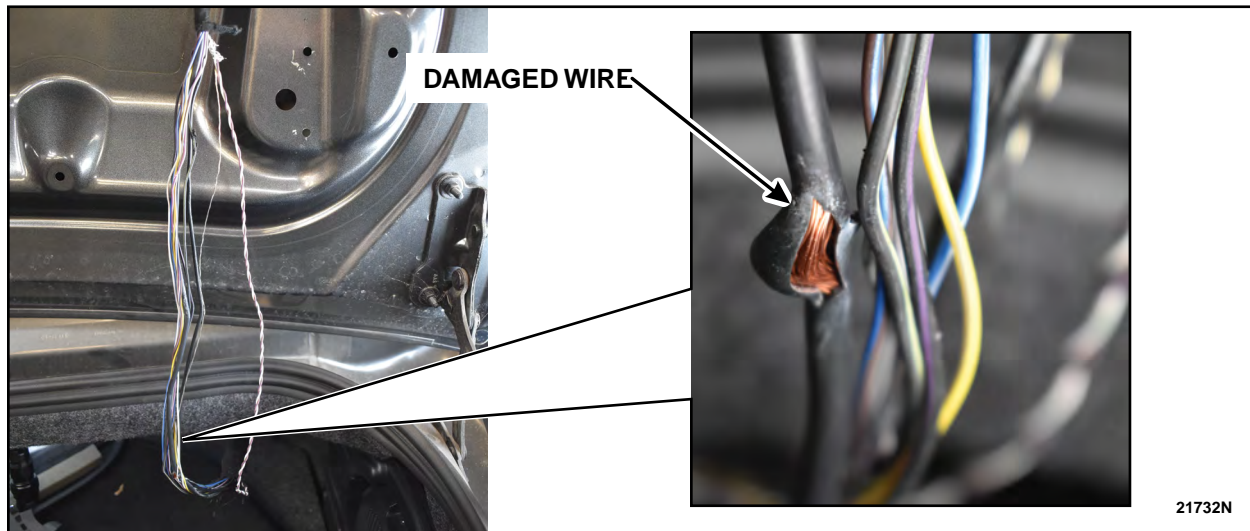
FIGURE 15

In all of the affected vehicles, damage to the luggage compartment lid wiring harness in the area of the right side luggage compartment lid hinge may lead to intermittent rear view camera operation, loss of satellite radio reception, inoperative luggage compartment lamp and/or inoperable luggage compartment release.

**NOTE:** One example of wiring damage, others similar.

20. Cut out the damaged section of the harness. Make the cut at the location of the harness noted. See Figure 16.

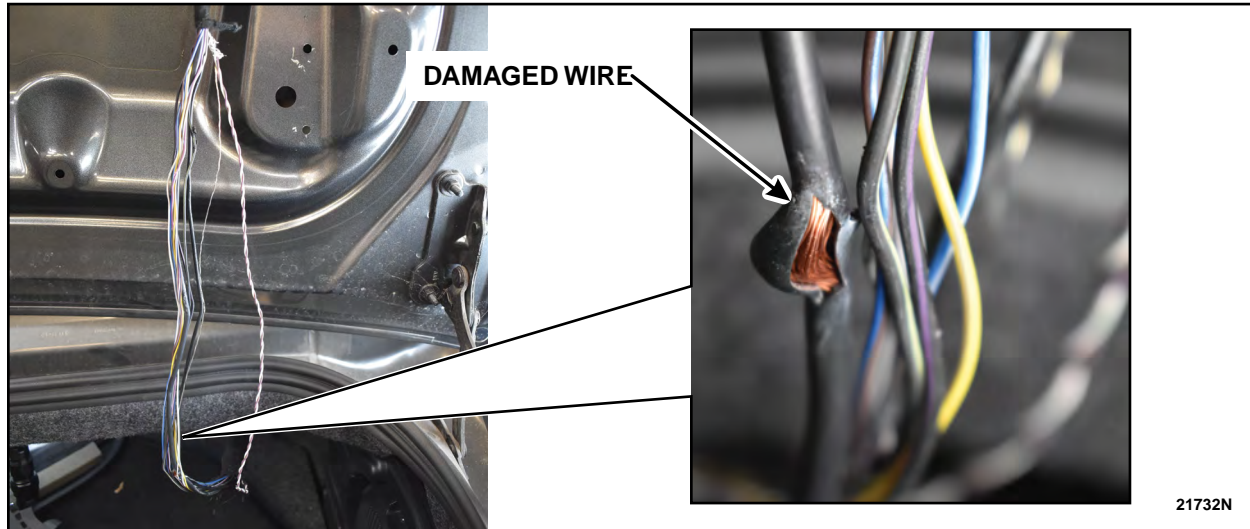
FIGURE 39

**Note:** One example of wiring damage, others similar.

53. Cut out the damaged section of the harness. Make the cut after the ground wire (front of vehicle side of harness) at the location of the harness noted. See Figure 40.
