HYUNDAI Technical Service Bulletin	GROUP AUTOMATIC TRANSMISSION	NUMBER 23-AT-006H-1
	DATE AUGUST 2023	MODEL PALISADE (LX2) SANTA FE (TMA) SANTA FE HYBRID (TM/TMa HEV) SONATA (DN8A) SONATA HYBRID (DN8 HEV) TUCSON (NX4/NX4A) TUCSON HYBRID (NX4 HEV)
SUBJECT: AUTOMATIC TRANSAXLE PUSH-BUTTON SHIFTER DIAGNOSIS

This TSB supersedes TSB 23-AT-006H to add an additional applicable model, an additional diagnostic trouble code (DTC) P0706, and modify the service procedure on step 6.**

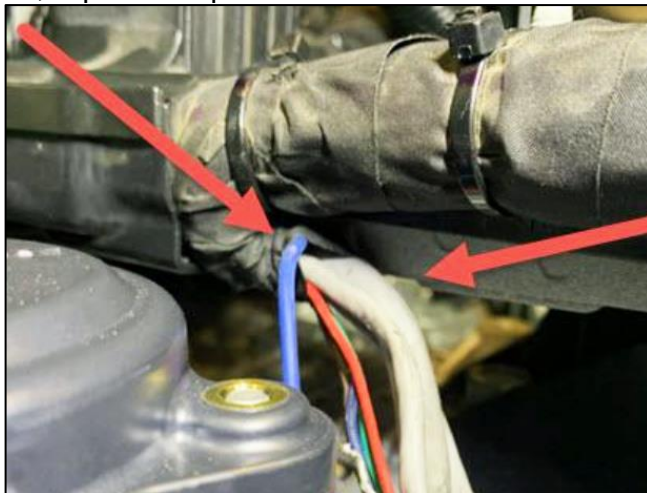
Santa Fe (TMA) 2.5L – (VINs begin with 5NM)

Carefully unwrap the harness protector in the area shown below. Check the insulation on the wires to see if the insulation has been damaged by contact with the battery tray. If so, repair or replace the control harness.

If replacing the control harness, make sure the replacement harness does not contact the battery tray/other components. Otherwise, the harness may become damaged again.

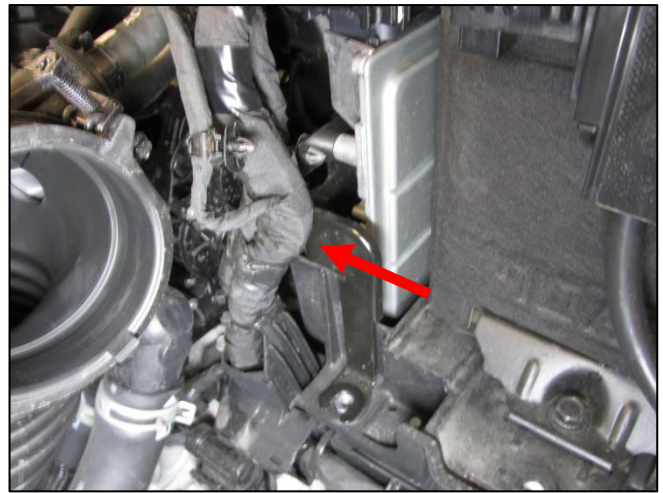
Tucson (NX4) 2.5L – (VINs begin with KM8)

Carefully unwrap the harness protector in the area shown below. Check if the insulation has been damaged by contact with the metal bracket. If so, repair or replace the control harness.
