Stacy L. Balzer  
 Operating Director  
 Service Engineering Operations  
 Ford Customer Service Division

December 14, 2022

**SUBJECT:** **NEW VEHICLE DEMONSTRATION / DELIVERY HOLD**  
**Safety Recall 22S06 - Supplement #2**  
 Certain 2015-2017 Model Year Mustang Vehicles  
 Luggage Compartment Lid Wiring Inspection and Rear View Camera Improper Function

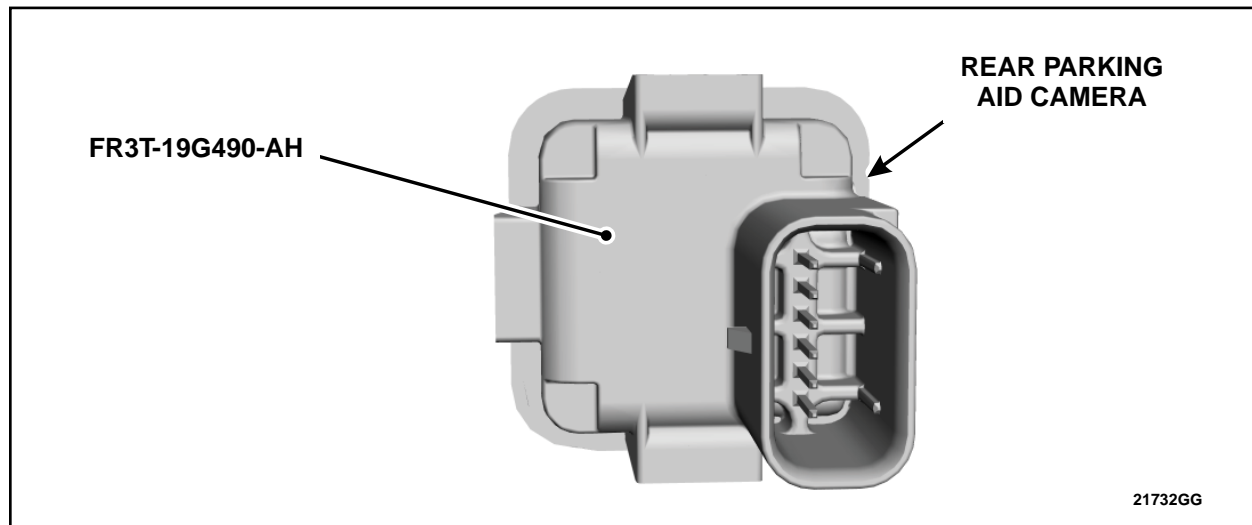
**FIGURE 1**

3. With the rear parking aid camera out of the vehicle, inspect the engineering part number on the back of the camera. See Figure 1.

**NO** - Replace the Rear Parking Aid Camera. Please follow the WSM procedures in Section 413-13B. Do not install the luggage compartment lid trim at this time. Proceed to Step 4.

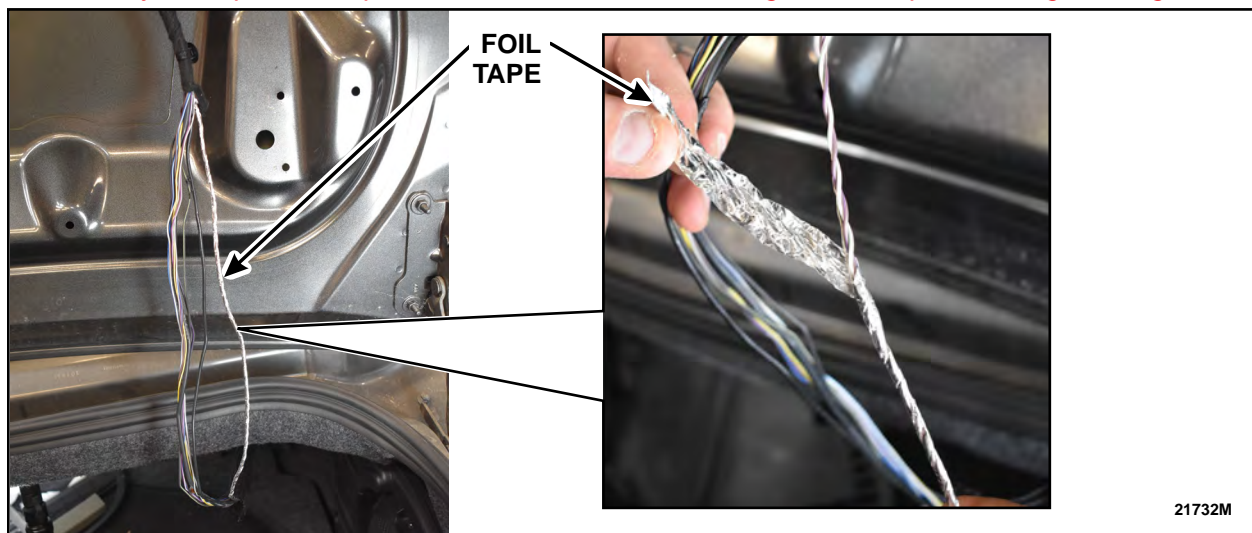
**FIGURE 14**

19. Inspect the entire exposed portion of the wiring harness for any sign(s) of damage or chafing.

- Is any damage or chafing found?

20. Cut out the damaged section of the harness. Make the cut at the location of the harness noted. See Figure 16.

21. Splice in the *new* section of harness, matching wire colors on the existing vehicle harness and the replacement section of harness as necessary. Follow the recommended wiring splice procedures in Section 5 of the Wiring Diagram using solder not wire crimps. Stagger the location of each of the wire splices along the harness to minimize the overall size of the repair.

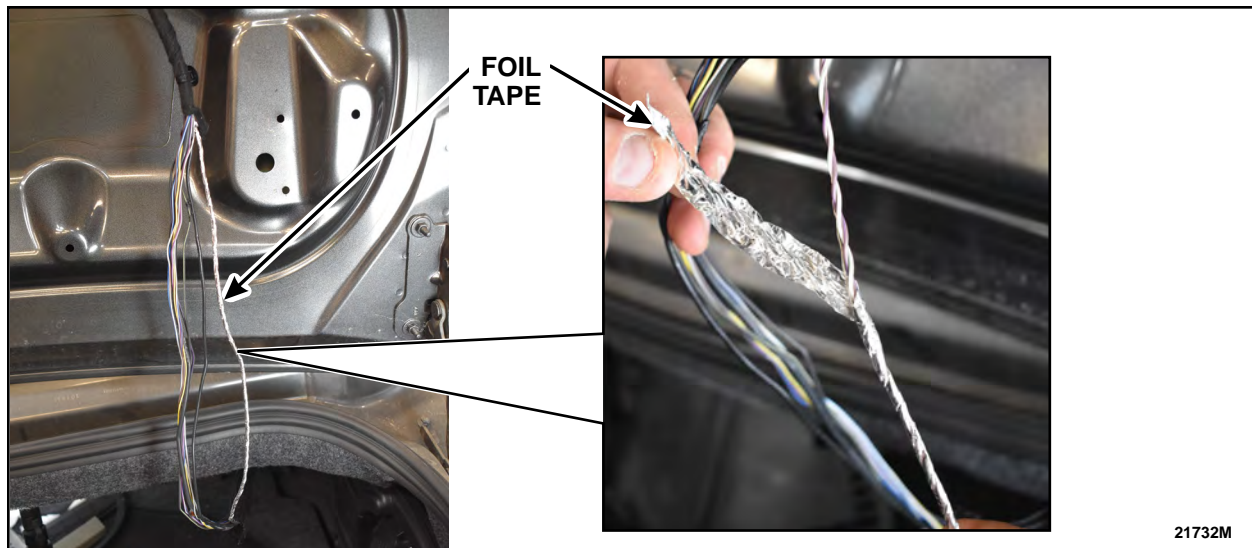
**FIGURE 38**

52. Inspect the entire exposed portion of the wiring harness for any sign(s) of damage or chafing.  
See Figure 39.

- Is any damage or chafing found?

53. Cut out the damaged section of the harness. Make the cut after the ground wire (front of vehicle side of harness) at the location of the harness noted. See Figure 40.

54. Splice in the *new* section of harness, matching wire colors on the existing vehicle harness and the replacement section of harness as necessary. Follow the recommended wiring splice procedures in Section 5 of the Wiring Diagram using solder not wire crimps. Stagger the location of each of the wire splices along the harness to minimize the overall size of the repair.
