HYUNDAI Technical Service Bulletin	GROUP AUTOMATIC TRANSMISSION	NUMBER 23-AT-006H-1
	DATE AUGUST 2023	MODEL PALISADE (LX2) SANTA FE (TMA) SANTA FE HYBRID (TM/TMa HEV) SONATA (DN8A) SONATA HYBRID (DN8 HEV) TUCSON (NX4/NX4A) TUCSON HYBRID (NX4 HEV)
SUBJECT: AUTOMATIC TRANSAXLE PUSH-BUTTON SHIFTER DIAGNOSIS

This TSB supersedes TSB 23-AT-006H to add an additional applicable model, an additional diagnostic trouble code (DTC) P0706, and modify the service procedure on step 6.**

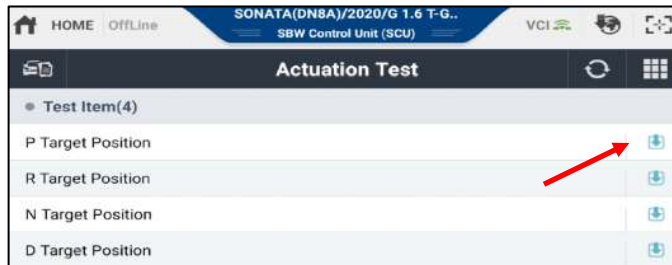
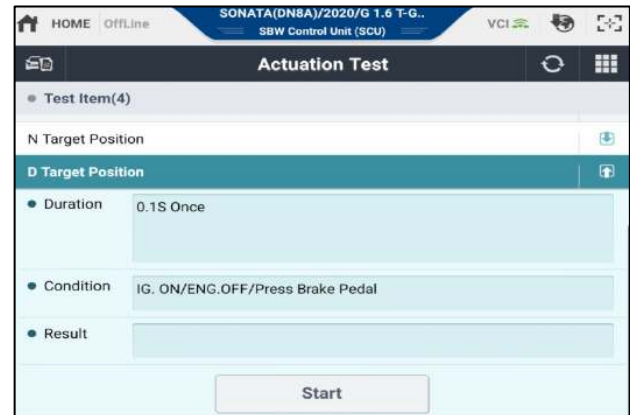
5. Turn the engine off and push the SSB 2 times to turn the ignition **ON**. Press the brake pedal. From the GDS home screen, select **Actuation Test** and **SCU** menu. Test the Target position for P, R, N and D. Press the arrow to change the selection. If the GDS and cluster show:
- Correct **Target Position** for P, R, N and D: The SCU sent electrical current to the SBW actuator, the SCU and SBW actuator are currently operating correctly and the related harness currently does not have an open/short circuit. Go to Step 6.
 - Does not show the correct **Target Position** for P, R, N and D: The SCU, SBW actuator or related harness may have a fault.
