## **Troubleshooting Guide for Cisco NCS 1010, IOS XR Release 24.3.x**

# General Troubleshooting

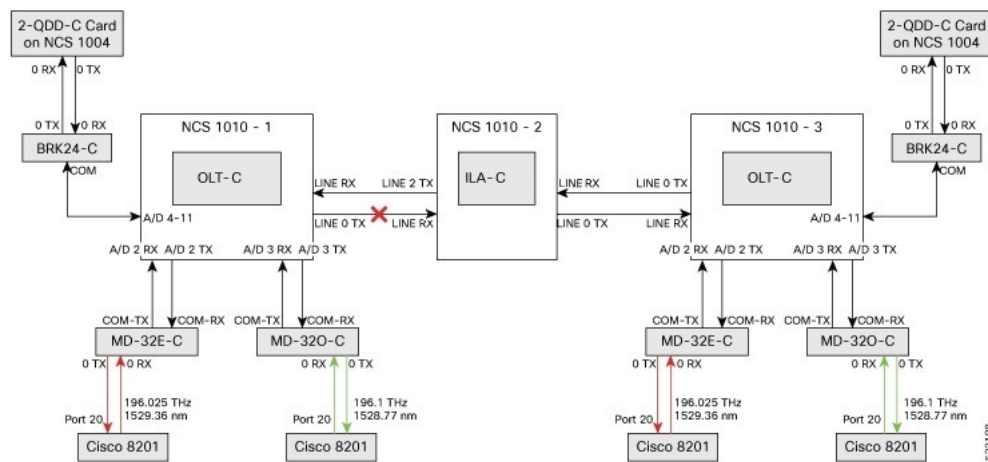
**Figure 6: Fiber Cut at the Line OTS Controller**

The following figure shows loss of fiber connection continuity at the Line port:

The following example shows how to determine a span failure. Look for the highlighted alarms in the **show controllers** output.
