1G/10G/25G/40G/100G Optical Transceiver Troubleshooting Manual

I、 Document Background

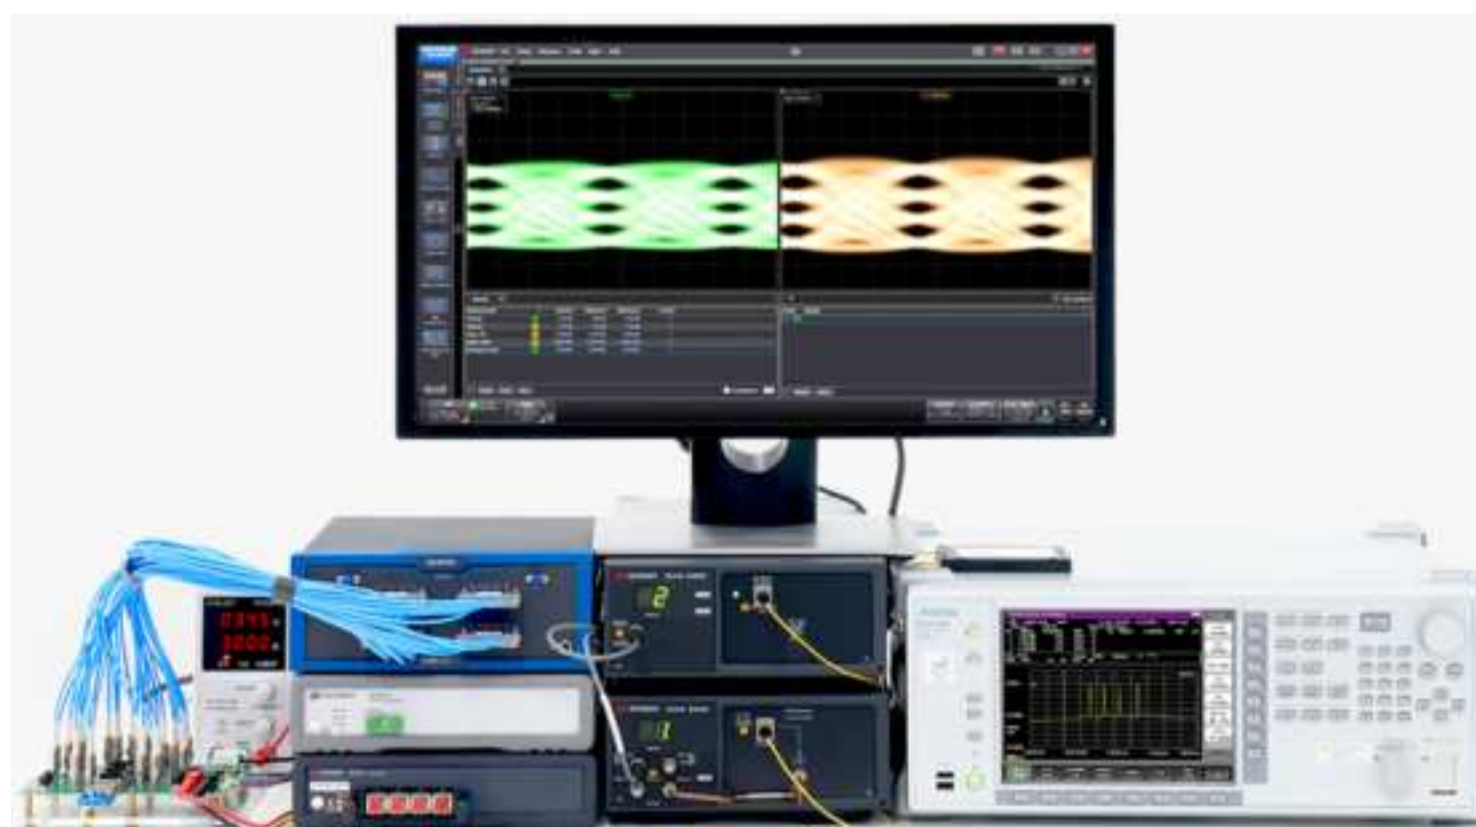
- **PAM4 Encoding:** PAM4 encoding uses four signal levels to represent two bits (00, 01, 10, 11). These levels are closer together compared to the levels in NRZ/PAM2, making signal integrity a more significant concern. PAM4 encoding is used for products with channel speeds of ≥ 50Gbps.

The above shows the optical eye diagram output results of the PAM4 optical module from the FS laboratory.
