TSB • Fuel System • [14-FL-006] ECM UPDATE - P2096 AND/OR MISFIRE DTC (S)

HYUNDAI NEW THINKING. NEW POSSIBILITIES. Technical Service Bulletin	GROUP	NUMBER
	FUEL SYSTEM	14-FL-006
	DATE	MODEL(S)
	November, 2014	ELANTRA (MD/UD)
SUBJECT:	ECM UPDATE – P2096 AND/OR MISFIRE DTC(s)

THIS TSB SUPERSEDES TSB 13-FL-006 WITH A REVISED ECM UPDATE AND OP CODE.

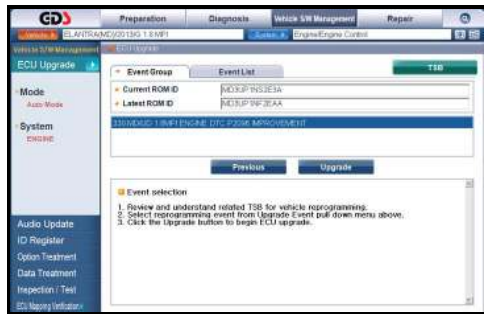
- Update event "**330. UD/MD 1.8MPI ENGINE DTC P2096 IMPROVEMENT**" will display. Select **Upgrade**.

- If the screen indicates "**Voltage is OK**" (voltage > 12volts), select **OK**. If not, select **CANCEL** and charge the vehicle battery by running the engine for 10 minutes.
- Updating will occur until 100% is reached on the bar graph. At the prompt, turn the ignition key OFF for 10 seconds, then turn it ON and select **OK**.
- The GDS will confirm that ECM reprogramming is successfully finished. Select **OK**.
- If the ECM update was not successful, go to **GDS MANUAL MODE ECM UPDATE PROCEDURE**.
- Check for DTC in all systems and Erase All DTC that stored due to loss of CAN communication during the ECM Update.
- Turn **OFF ignition for 10 seconds** then turns **ON** before going to engine start.
- Start the engine to confirm proper operation.
