AUTOMOTIVE TAIL

LIGHT ASSEMBLIES

MODEL: 03SDHB/99SDBK/02SSBK

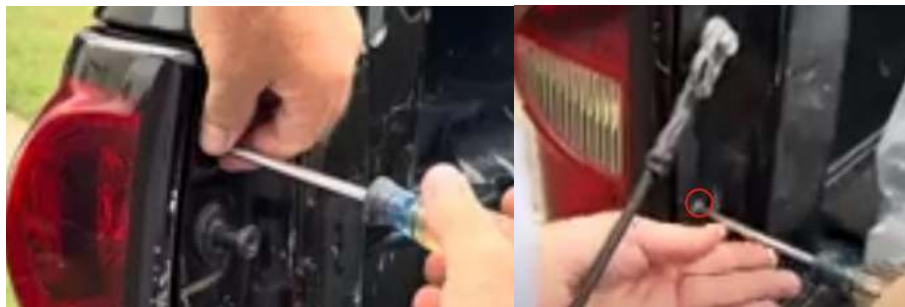
1. Open the tailgate ,remove 2 Phillips screws

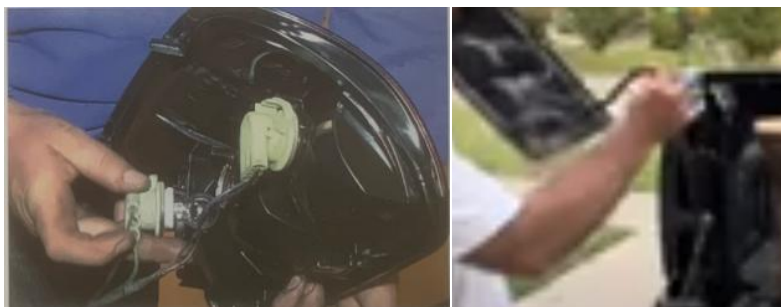
2. Remove the original factory taillight assembly, and all taillight sockets and bulbs (Note: The original reversing lights need to be retained and installed on the new lights).

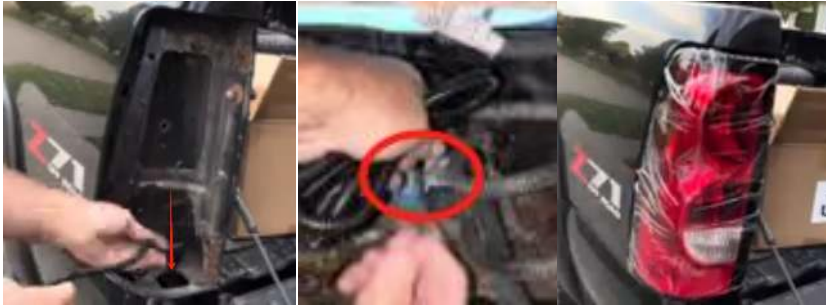
1. Locate taillight assembly, connect taillight harness and set taillight assembly in place.

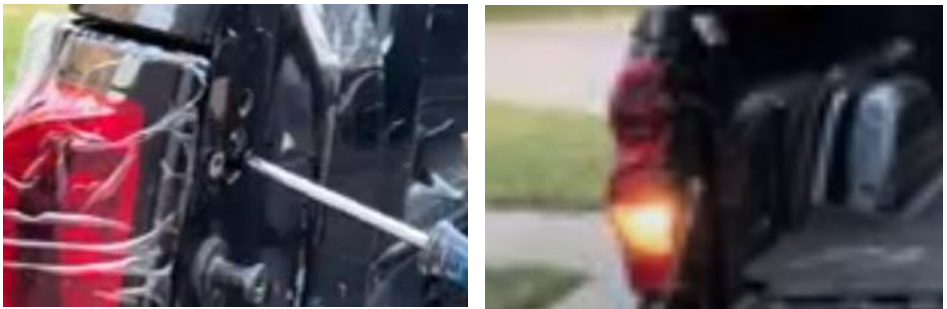
2.Reinstall 2 Phillips screws and test our light make sure everything works as it should.

※The above figure shows the replacement of only one of the models, the operation process is similar for other models.
